# Petersburg Medical Center

## Seismic Evaluation Report

July 2019

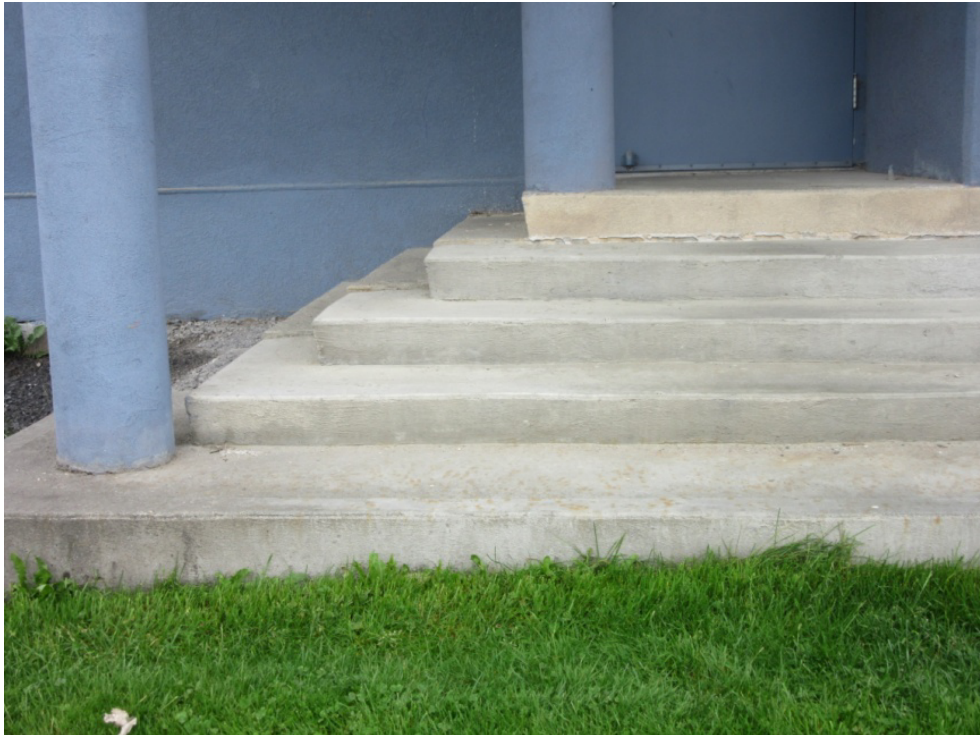
Figure 2-4: Settlement at Long Term Care Wing Exterior Stair

Minor settlement of the exterior stair on the west side of the building relative to the building was noted at the Long Term Care Wing. See Figure 2-4. If these concrete stairs are supported on spread footings, whereas the building is pile supported, that could account for the settlement.

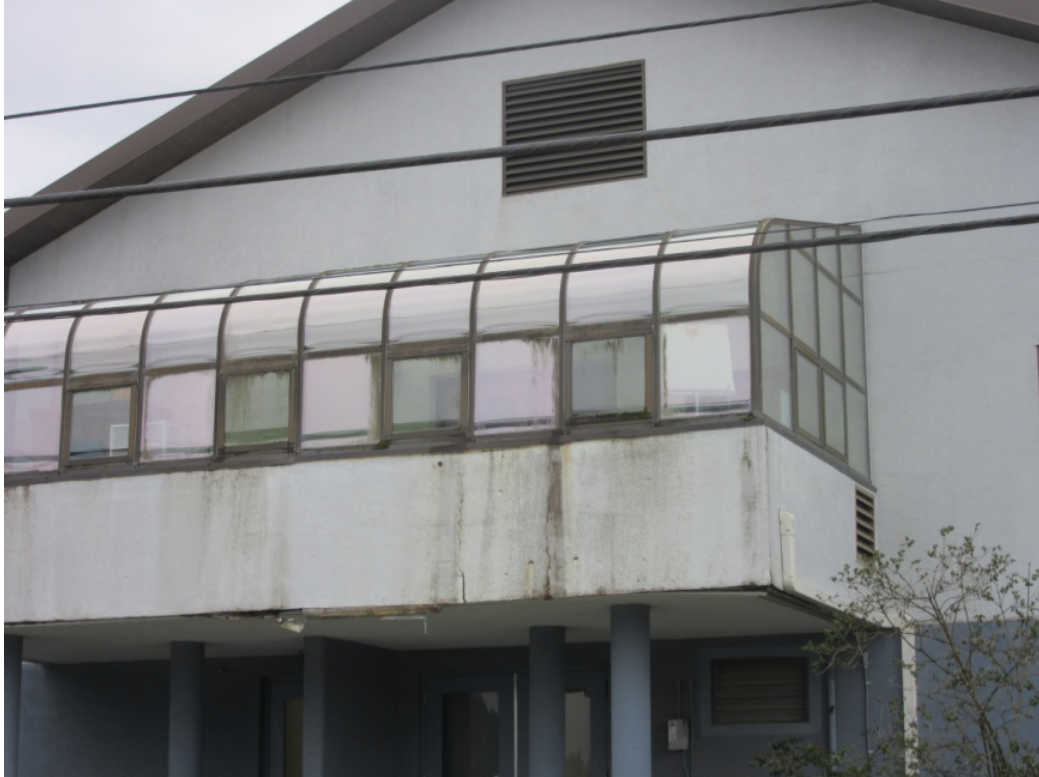
Figure 2-5: Cladding Damage at Long Term Care Wing Exterior Sun Room

The cladding at the sun room at the west side of the Long Term Care Wing is damaged, likely due to weather and water penetration issues. See Figure 2-5. There is no apparent damage to the building structure in this area.

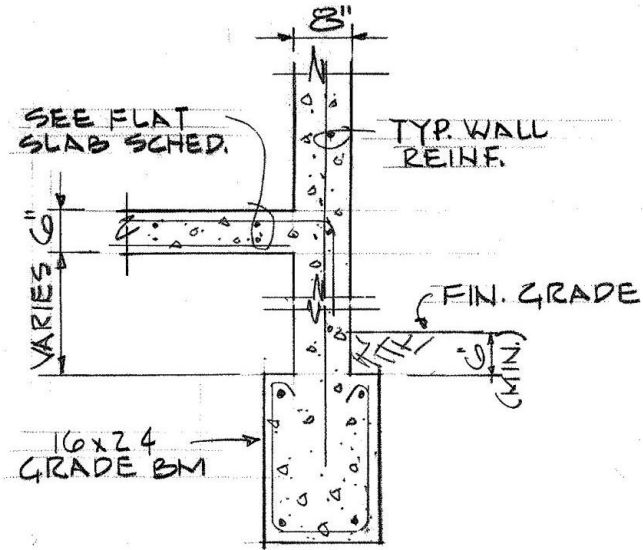
Figure A1: Long Term Care Wing – Foundation Dowels (Section F/S-3)

- **Building Type C2 - Foundation Dowels:** Concrete shear wall vertical reinforcement dowel embedment lengths into the foundations are less than that required to develop the strength of the walls. For reference, see Section F/S-3 shown in Appendix A, Figure A1.
- **Building Type C2 - Deep Foundations/Connections:** Cedar pile tension capacities unknown. No tension connection between piles and pile caps to resist uplift. No top reinforcement in pile caps. For reference, see Section 1E/S-2 shown in Appendix A, Figure A2.
- **Building Type S4 – Connections:** Attic horizontal bracing system has insufficient capacity to transfer lateral forces to concrete shear walls.

| C | (NC) | N/A | U | FOUNDATION DOWELS: Wall reinforcement is doweled into the foundation and the dowels are able to develop the lesser of the strength of the walls or the uplift capacity of the foundation. (Commentary: Sec. A.5.3.5. Tier 2: Sec. 5.7.3.4) |

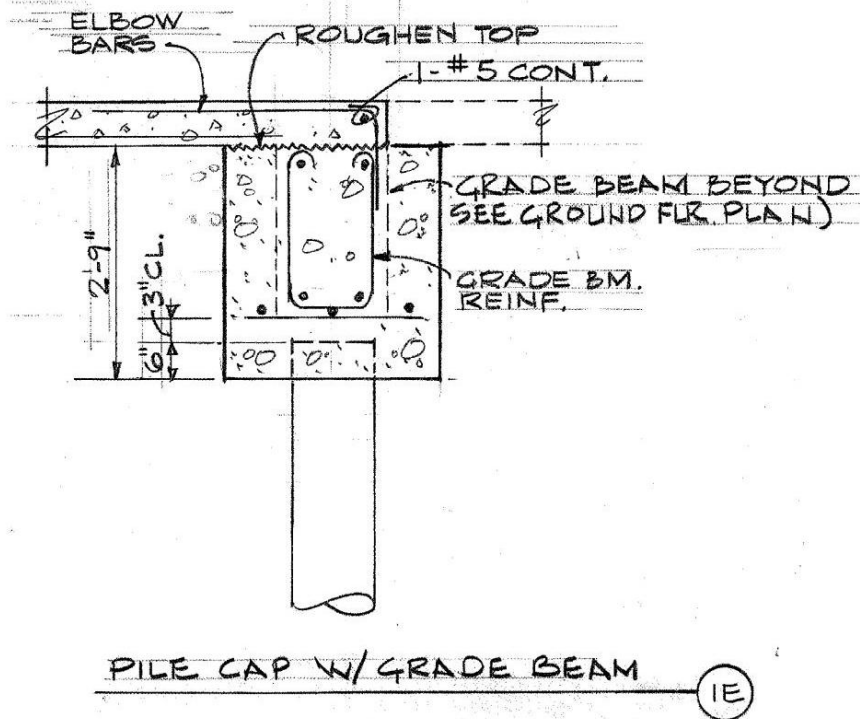
Figure A2: Long Term Care Wing – Deep Foundations/Connections (Section 1E/S-2)

| C | NC | N/A | (U) | DEEP FOUNDATIONS: Piles and piers are capable of transferring the lateral forces between the structure and the soil. (Commentary: Sec. A.6.2.3) |

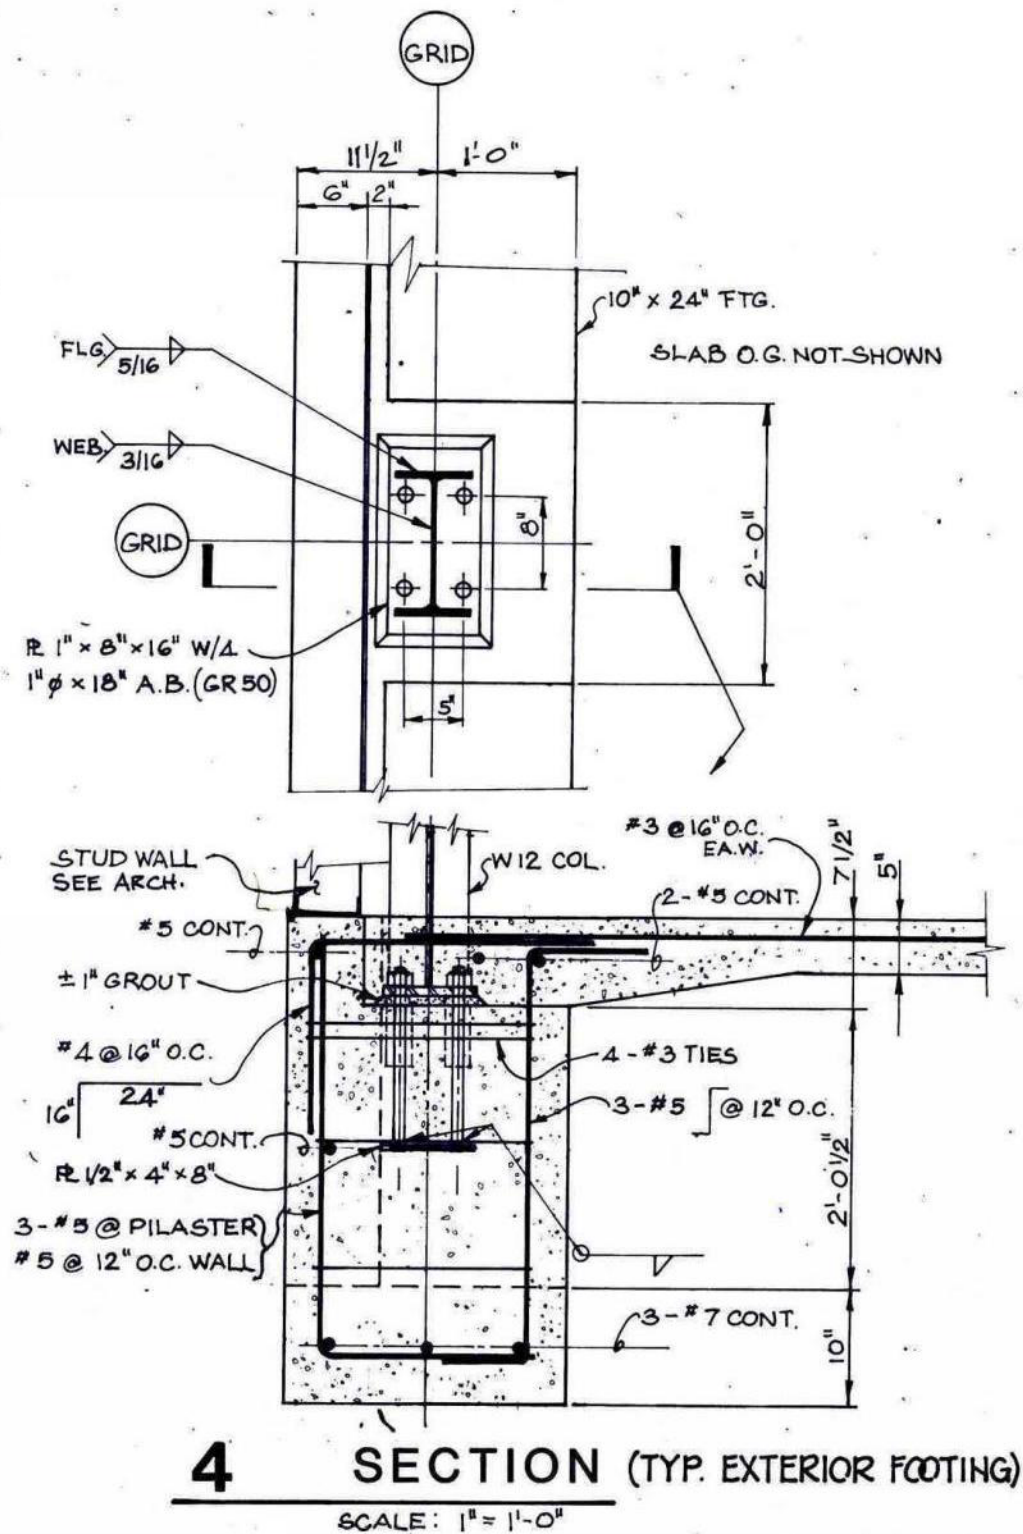
Figure A3: Hospital – Steel Columns (Section 4/S-7)

- **Building Type S1 – Steel Columns:** Connections of moment frame columns to foundations insufficient to develop tensile capacity of columns. For reference, see Section 4/S-7 shown in Appendix A, Figure A3.

C    **(NC)**    N/A    U    STEEL COLUMNS: The columns in seismic-force-resisting frames are anchored to the building foundation, and the anchorage is able to develop the least of the tensile capacity of the column, the tensile capacity of the lowest level column splice (if any), or the uplift capacity of the foundation. (Commentary: Sec. A.5.3.1. Tier 2: Sec. 5.7.3.1)

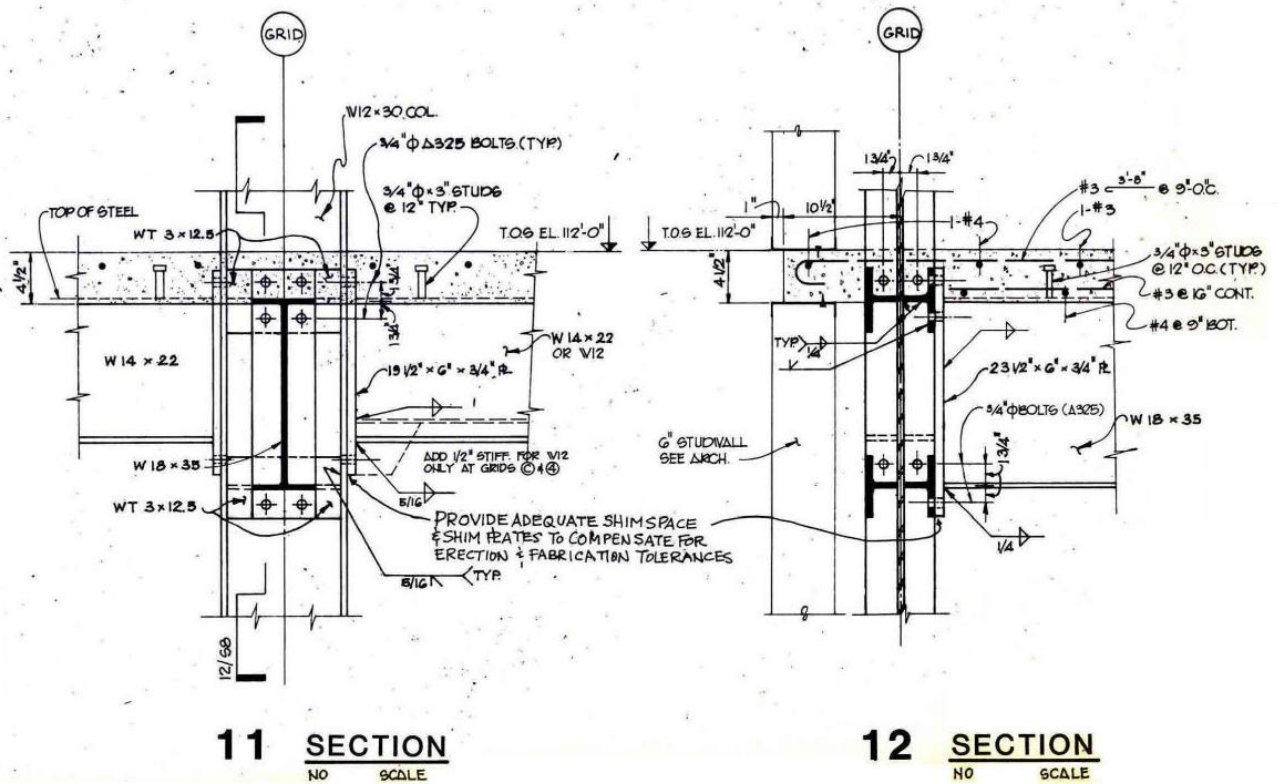
Figure A4: Hospital – Moment-Resisting Connections/Girder Flange Continuity Plates (Section 11/S-8 and 12/S-8)

- **Building Type S1 – Moment-Resisting Connections:** Based on information provided on the drawings, it cannot be verified and is considered unlikely that moment frame connections are able to develop the strength of the beams. For reference, see Sections 11/S-8 and 12/S-8 shown in Appendix A, Figure A4.

- **Building Type S1: Compact Members:** Moment frame members do not meet compact section requirements.
- **Building Type S1: Girder Flange Continuity Plates:** There are no girder flange continuity plates at the moment frame joints. For reference, see Sections 11/S-8 and 12/S-8 shown in Appendix A, Figure A4.
